HABITAT IMPROVEMENT AND MONITORING PROJECT

MONITORING YEAR 1 OF 5

DOLAN PROPERTY; COLDWATER RIVER

December, 2011

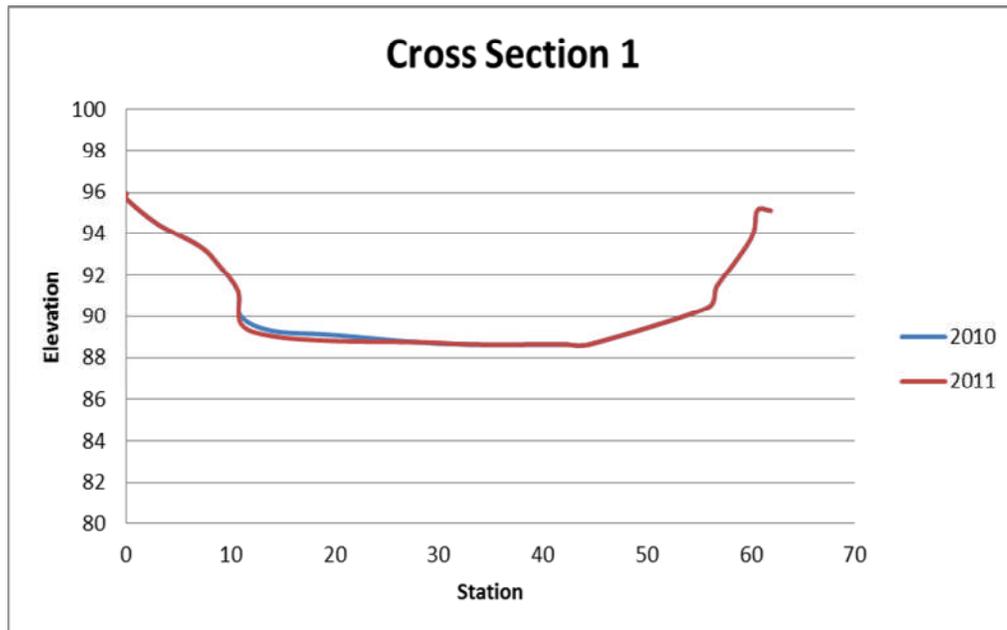
Figure 5. Annual Survey of Cross Section 1 on the Dolan Property.

Four permanent cross sections were established within the project area (Figures 3 and 4). Little change was found in the cross sections during the period immediately following construction until one-year post construction (Figures 5-8).

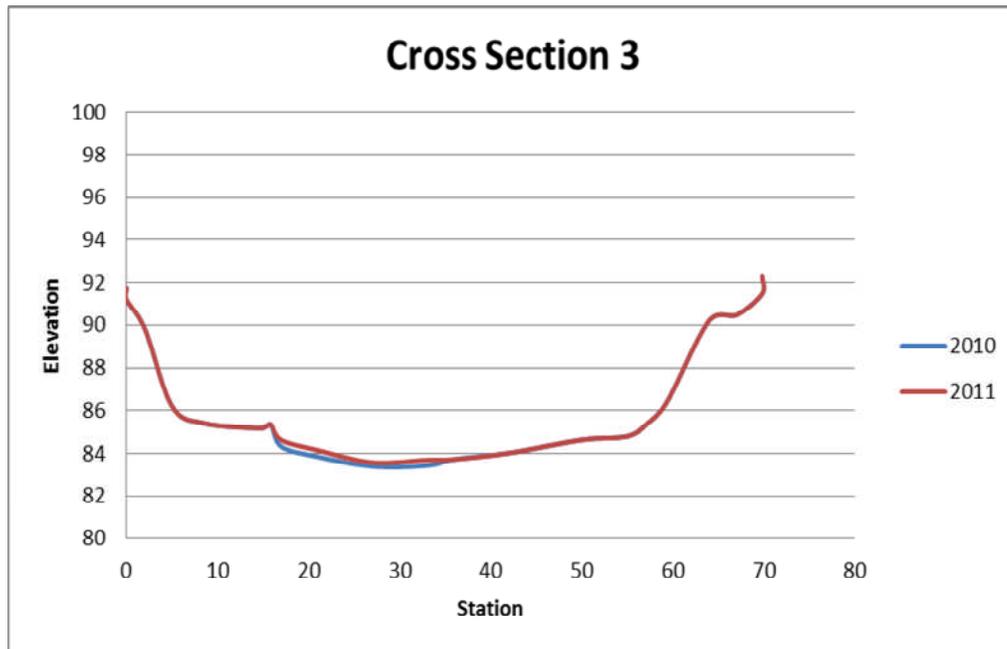
Figure 7. Annual Survey of Cross Section 3 on the Dolan Property.

Four of five bank pin sites did not change in the first year; one of these sites gained streambank from significant deposition of sediment (Table 6). One site, Site 4 at Cross Section 3, experienced significant, localized erosion of about 0.6 feet of streambank.
