HABITAT IMPROVEMENT AND MONITORING PROJECT

MONITORING YEAR 1 OF 5

DOLAN PROPERTY; COLDWATER RIVER

December, 2011

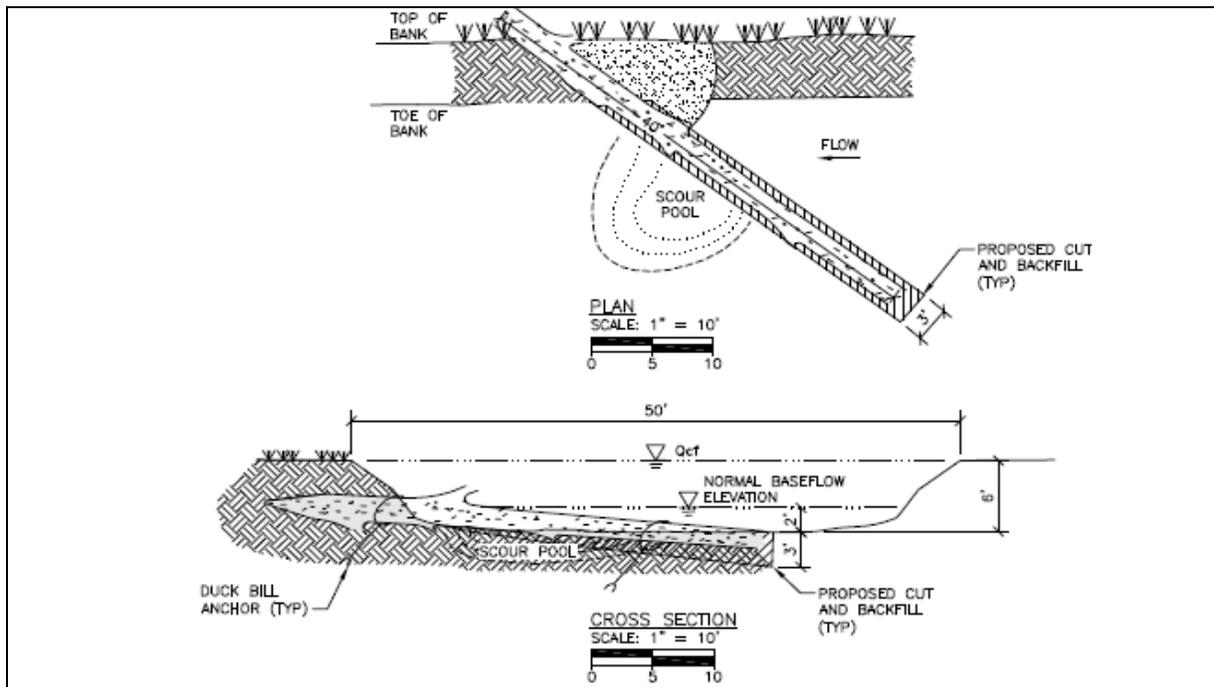
Figure 2. Typical log habitat structure

In September 2010, a total of 38 trees were harvested from the Dolan Property and used to build 35 structures at 31 distinct locations within the river (Figures 2-4). Approximately 90% of the trees were sycamore, with the remainder being dead ash, basswood and maple. No trees were cut within 25 feet of the ordinary high water mark of the Coldwater River. Construction of the log vanes included excavation of a trench in the river bottom, placement of a large log in the trench, and backfill with the originally excavated material.

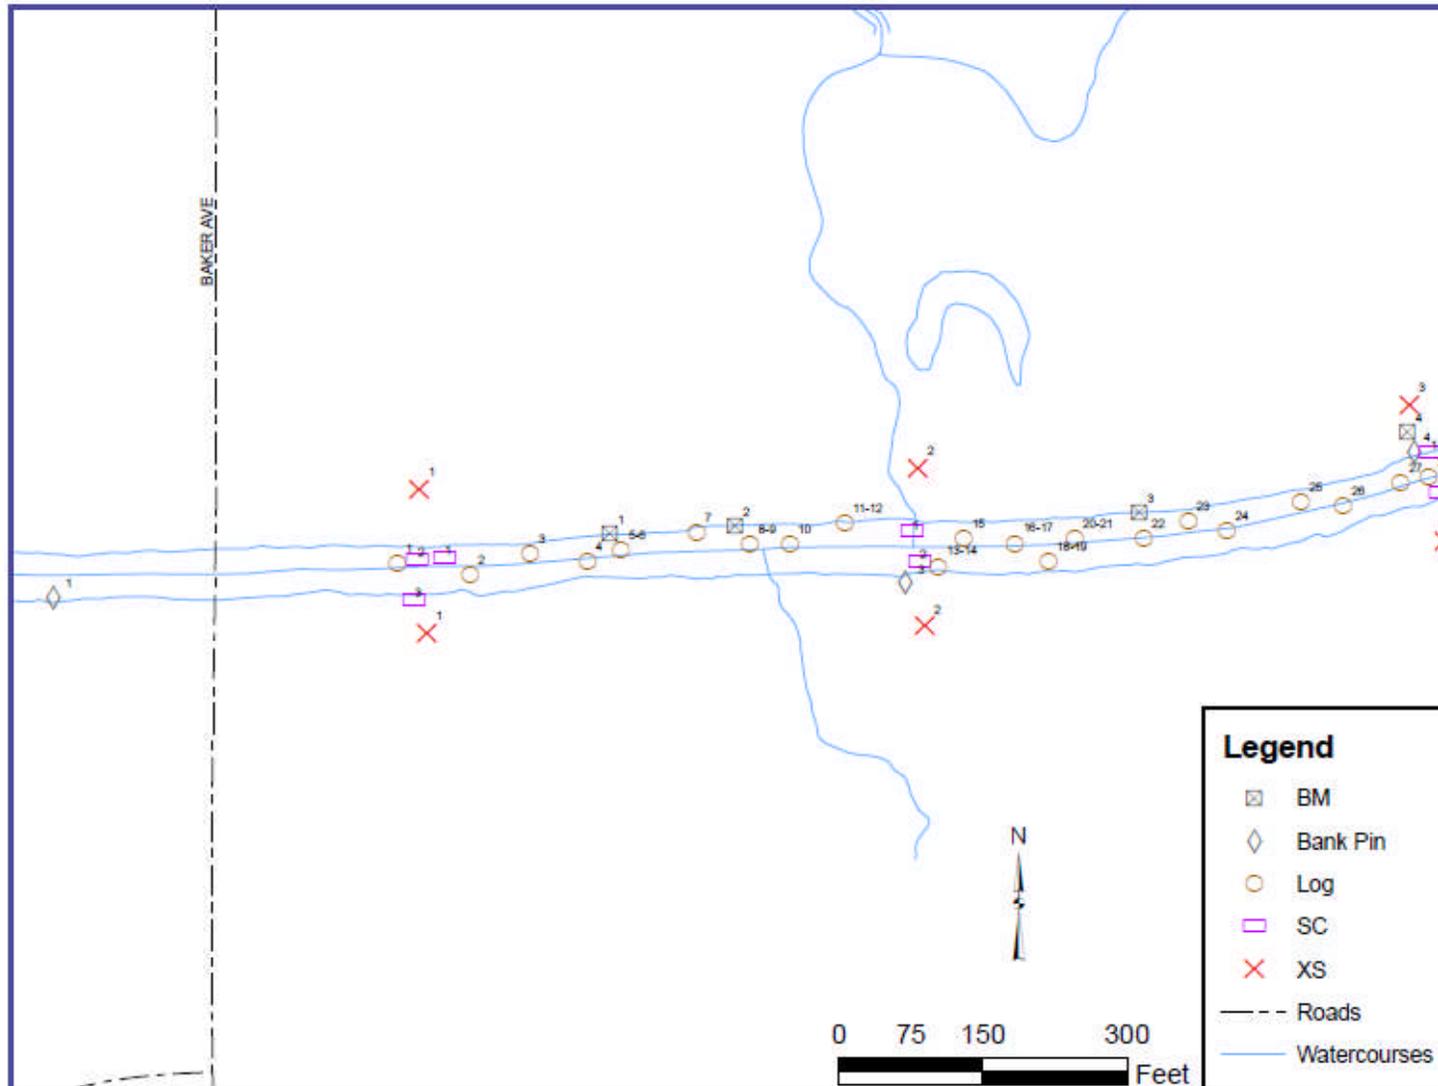
Figures 3. Location of monitoring cross sections, bank pins and scour chains. (West portion of project area).

Four permanent cross sections were established within the project area (Figures 3 and 4). Little change was found in the cross sections during the period immediately following construction until one-year post construction (Figures 5-8).
